Bureau of Mines Information Circular/1986

Evaluation of Safety Shutoff Valve System on Methane Gas Pipelines Under Mine Fire Conditions

By Patrick A. Kinek, Thomas E. Marshall, and Gerald L. Finfinger

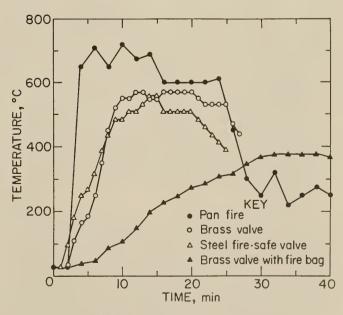
FIGURE 3. - Results of fire test.

Initially, in each test, a pan fire using 15 gal of kerosene was ignited under the unprotected valve, producing temperatures of 500° to 700° C over a 30-min period. Both valves recorded an internal temperature of 500° to 550° C on the seats at 11 min (fig. 3); this is the temperature range in which Teflon polymer begins decomposing extensively. Not surprisingly, for tests with both valves the flow meter began rising after approximately 11 min, indicating a leak in the system through the valve.

An important observation was that the inexpensive brass valve performed as well as the more expensive fire-safe valve. Low line pressure and the absence of a liquid medium rendered the fire-safe valve as ineffective at high temperatures as the brass valve. Given this finding, it was decided to use only the brass valve for the "fire bag" tests.

Once the shutoff valve system was constructed, the valve was wrapped in the "fire bag." Twenty gallons of kerosene was used for these tests to extend the life of the fire from 30 min to 40 min. The kerosene was ignited, and after 20 s the PVC pipe burst, confirming its effectiveness as a fire warning mecha-As a result, air pressure on the actuator was released, causing the valve to close and stopping the flow of nitrogen gas. After 40 min of fire exposure at temperatures between 500° and 700° C, the ball valve seat and stem seal were still intact and maintaining line pres-The internal temperature on the sure. Teflon seat was only 380° C at the end of the 40-min period (fig. 3), as compared with 550°C after 11 min without the "fire bag" (fig. 3).

The results of the investigation indicate that the ball valves now used in the Bureau's methane drainage pipeline system can be retrofitted with an inexpensive "fire bag" to substantially increase the system's short-term integrity under mine fire conditions. It was also established that the more expensive fire-safe ball valves are no more effective at sealing
